The Design, Construction and Testing of an Intelligent Device for Coating Flaws and Crack Detection in Pipelines

Original Research Article

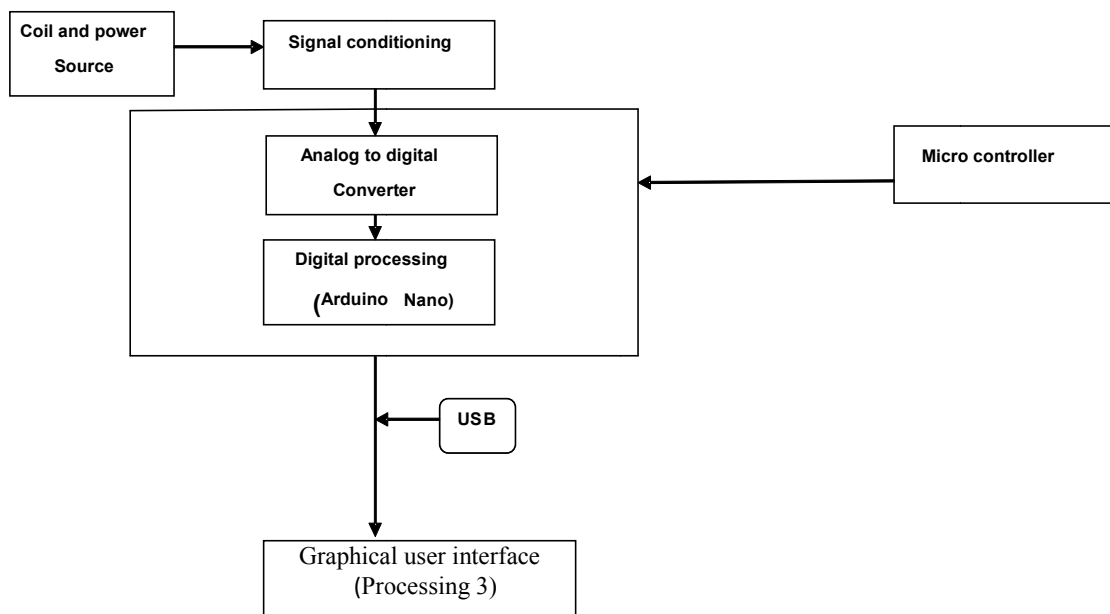
Fig. 2. Flow diagram denotes principal for eddy current testing device

The power of this system was sourced from a direct current 12V battery which controls supply channel for the individual components. The advantages of using coils as sensors for the eddy currents are the simplicity of their construction, the huge dynamic range and the possibility of focusing the sensor which is confirmed by De Haan, et al. [11]. The coils used as the probe sensor is made of copper wires and circular in design. Special profile encircling probes are designed for researchers and manufacturers to control surface and sub-surface defects in products with special profiles and shapes. The four coils in total are homogenous in dimensions and properties, these coils are connected in series to form a chain round the pipe for easy and complete testing of the pipe. The inner and external diameters of the coils stand at 5mm and 15mm respectively. The length of each of the coils are 110mm with resistance of 40Ω and excitation current of 50mA. All this was done to achieve the required sensitivity of the probe which is vital in flaw detection. Tian, et al. [38] took the relationship between coil size and sensitivity into account and proposed a method for reconstructing the flaw in order to determine the crack's depth. The coil had 600 number of turns and are connected to the microprocessor where the change in impedance experienced in the coil is filtered to leave only useful signal for processing as shown in Fig. 2.

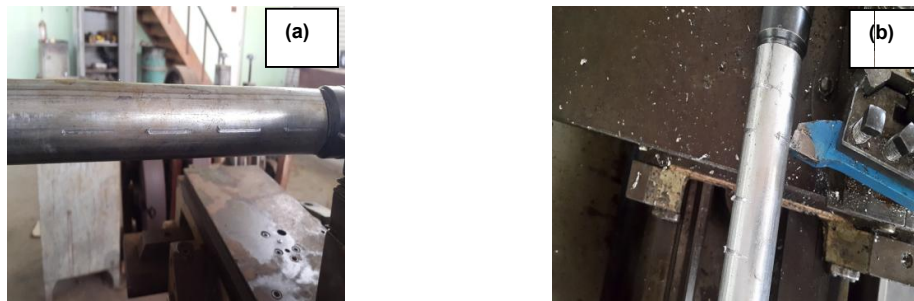
Fig. 3. Different side view of the tested cracked device (a) Longitudinal (b) Axial

Two Galvanized test pipes were purchased and cut into smaller lengths of 300mm with internal diameter of 30 mm and external diameter of 31.72 mm. These measurements were done with a ruler and digital Vernier caliper respectively while the abrasions machined using the lathe machine. This is done to imitate a pipeline with cracks on it for the device to detect. The galvanized steel pipes were chosen because of its close similarity to the pipeline in terms of the material which is steel with resistivity of $1.43 \times 10^{-7} \rho$ ($\Omega \cdot m$) and conductivity of $6.99 \times 10^6 \sigma$ (s/m). Below are the two orientations of cracks (longitudinal and axial cracks) with their dimensions and also the machining processing that was done on each of the pipes as shown in Fig. 3.

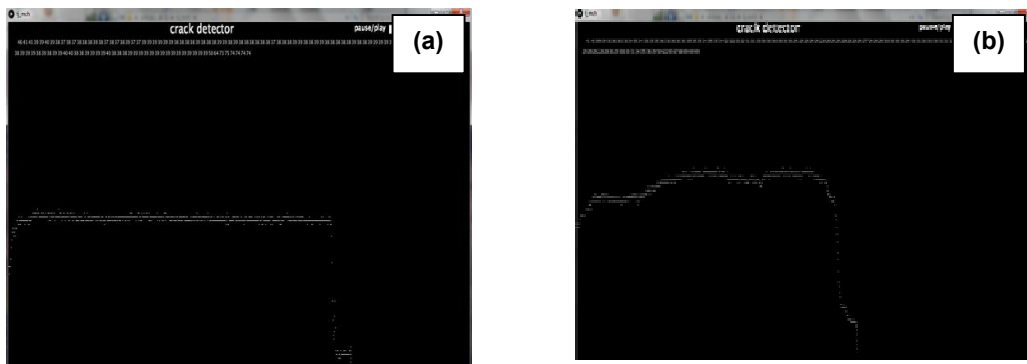
Fig. 5. Result from the tested done galvanized pipe (a) without defects (b) with longitudinal defects in section 1

This test shows the response of the coil on a defect free pipe. At the start of the test lift off caused a little change in the pulse signal but as the test progressed it was eliminated by maintaining a constant distance between the coil and the pipe. The relatively straight pulse signal shown on the screen of the computer system was expected as the impedance on the coil was

relatively constant and was not and altered in anyway due to absence of any form of defect on the test pipe. Shown below in Fig. 5 and Fig. 6 are the visual display of the test conducted using the Processing 3 software on a computer system. The numbers at the top of the screen is just to show the numerical values of the nverse of the change in impedance on the coil which is in line with the pulse signal displayed.
